CITY OF BALTIMORE WET WEATHER CONSENT DECREE SMOKE AND DYED WATER TESTING FORM										Page 2 of 14		
,	Sewershed	Company: REI/DRAYCO						Date: 09/29/2008				
Test Type: SMOKE				Ground Condition: Dry: X Damp:_ Wet:_						Supervisor: E.R.		
Manhole ID: S53GG_004MH				Test ID: S1039-005							J	upervisor. L.IX.
Field S	Sketch: (Shov			, blower pl							ıs, str	eet names, building addresses
Defect		Address	<u> </u>	Source	Loca			Draii		Severity	Π	
No.				Type			Sector	Area				Photo Number
	S53GG_00			1	5		1		30	4		1039-005_OB01-P01.jpg
	1204 EDISON HWY.			17	12	2	1	4(00	3		1039-005_OB02-P01.jpg
	3 1223 N. ELLWOOD AVE.			3	8		2	1		3	_	1039-005_OB03-P01.jpg
	4 1229 N. ELLWOOD AVE.			2	6		2	12		3		1039-005_OB04-P01.jpg
	B05 1235 N. ELLWOOD AVE.			2	6			2 9		3		1039-005_OB05-P01.jpg
	0B06 1239 N. ELLWOOD AVE.			2 8			2			3		1039-005_OB06-P01.jpg
	B07 1241 N. ELLWOOD AVE.			2					0 3			1039-005_OB07-P01.jpg

Unique Test ID: S1039-005 Date: 09/29/2008 Manhole ID: S53GG_004MH

CITY OF BALTIMORE SMOKE TESTING OBSERVATION SUMMARY OUTFALL SEWERSHED BALTIMORE CITY PROJECT 1039 REI/DRAYCO

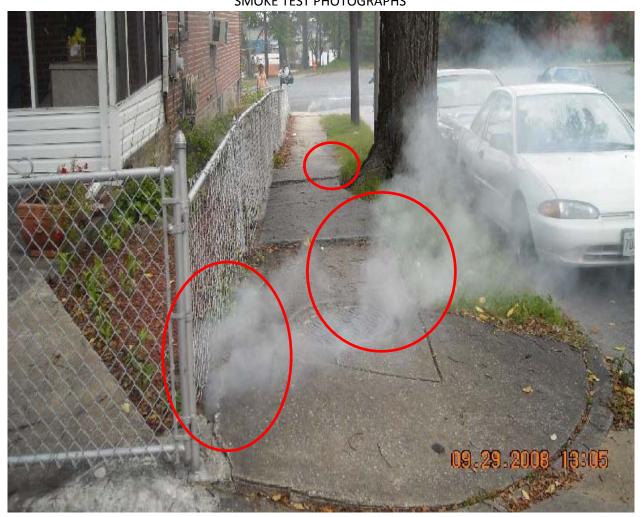
Photograph No: OB01-P01 Filename: S1039-005_OB01-P01.jpg

Defect No: OB01 Supervisor: E.R. Basin: Outfall

Source Type: 01 Main Sewer Sector: 01 Public

Location: 05 Sidewalk Severity: 04 Major Drainage Area: 120 ft²

Comments: The sewer runs straight ahead to the next manhole. The tree appears to have caused major defects along about 20' of the line.

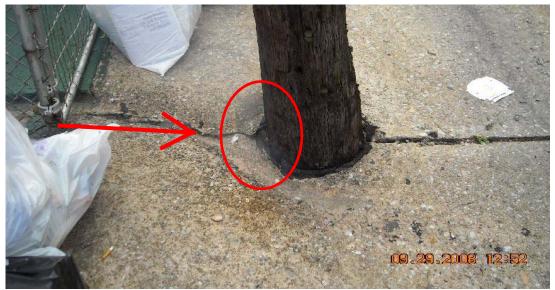
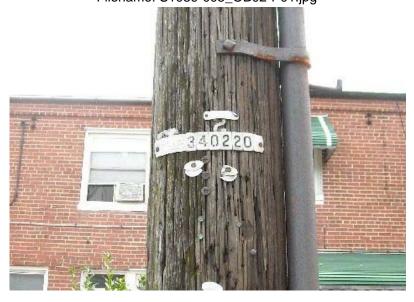
Defect No: OB02 Supervisor: E.R. Basin: Outfall

Source Type: 17 Telelephone Pole Sector: 01 Public

Location: 12 Alley Severity: 03 Moderate Drainage Area: 400 ft²

Comments: The base of this utility pole no. 340220 located behind the address is smoking. As you can see, the pole sits along drainage path, thus a rather large drainage area for this defect.

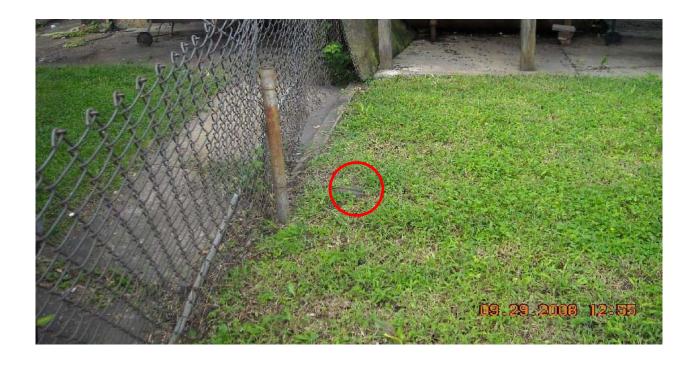
Photograph No: OB03-P01 Filename: S1039-005_OB03-P01.jpg

Defect No: OB03 Supervisor: E.R. Basin: Outfall

Source Type: 03 Cleanout Sector: 02 Private

Location: 08 Yard - Back Severity: 03 Moderate Drainage Area: 1 ft² Comments: An at-grade cleanout in the backyard of 1223 N. Ellwood Ave is smoking from a broken cap.

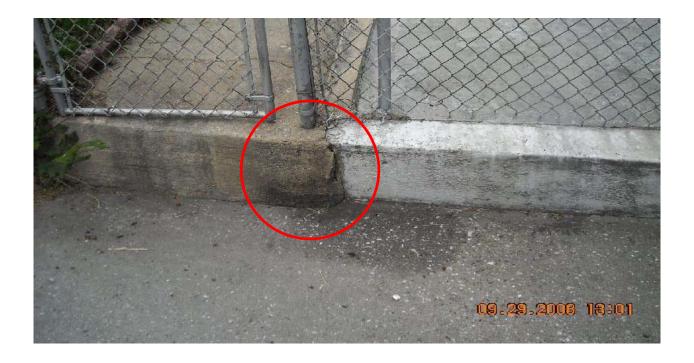
Photograph No: OB04-P01 Filename: S1039-005_OB04-P01.jpg

Defect No: OB04 Supervisor: E.R. Basin: Outfall

Source Type: 02 Service Line Sector: 02 Private

Location: 06 Curb Severity: 03 Moderate Drainage Area: 12 ft²

Comments: Smoke is coming from the cracks in concrete at 1229 / 1231 N. Ellwood Ave.

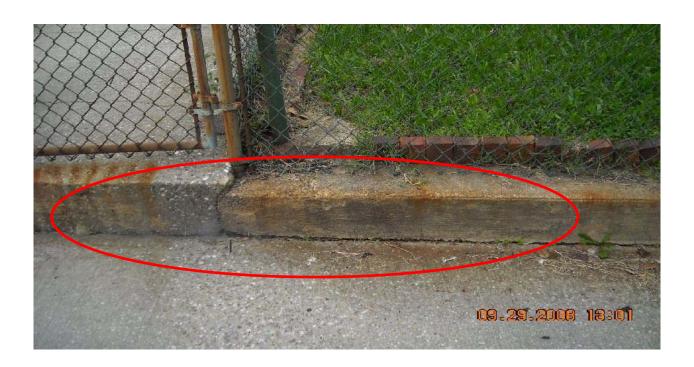
Photograph No: OB05-P01 Filename: S1039-005_OB05-P01.jpg

Defect No: OB05 Supervisor: E.R. Basin: Outfall

Source Type: 02 Service Line Sector: 02 Private

Location: 06 Curb Severity: 03 Moderate Drainage Area: 9 ft²

Comments: Smoke is coming from the cracks in concrete at 1235 / 1237 N. Ellwood Ave.

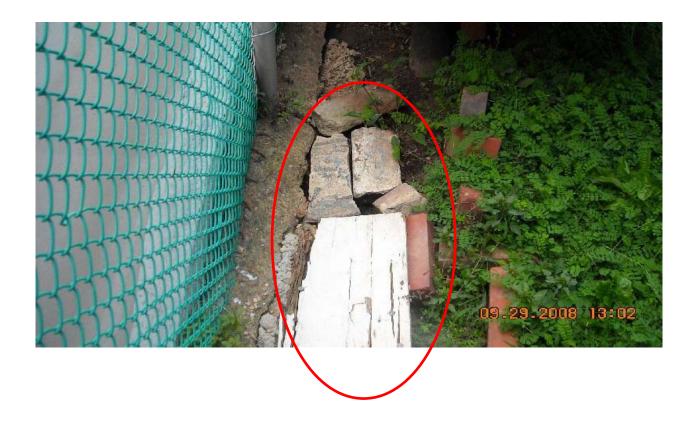
Photograph No: OB06-P01 Filename: S1039-005_OB06-P01.jpg

Defect No: OB06 Supervisor: E.R. Basin: Outfall

Source Type: 02 Service Line Sector: 02 Private

Location: 08 Yard - Back Severity: 03 Moderate Drainage Area: 9 ft²

Comments: Smoke is coming from the area along the fence.

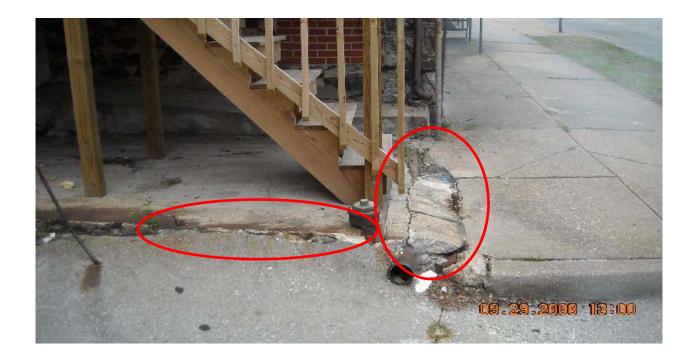
Photograph No: OB07-P01 Filename: S1039-005_OB07-P01.jpg

Defect No: OB07 Supervisor: E.R. Basin: Outfall

Source Type: 02 Service Line Sector: 02 Private

Location: 01 Paved Concrete Severity: 03 Moderate Drainage Area: 30 ft² Comments: Smoke is coming from along the service line in front of the steps, and along the curb to the

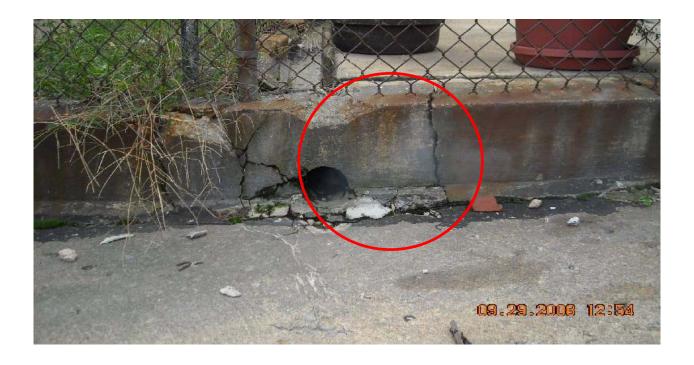
Photograph No: OB08-P01 Filename: S1039-005_OB08-P01.jpg

Defect No: OB08 Supervisor: E.R. Basin: Outfall

Source Type: 02 Service Line Sector: 02 Private

Location: 06 Curb Severity: 03 Moderate Drainage Area: 4 ft²

Comments: Smoke is coming from the cracks in the concrete curb behind residence.

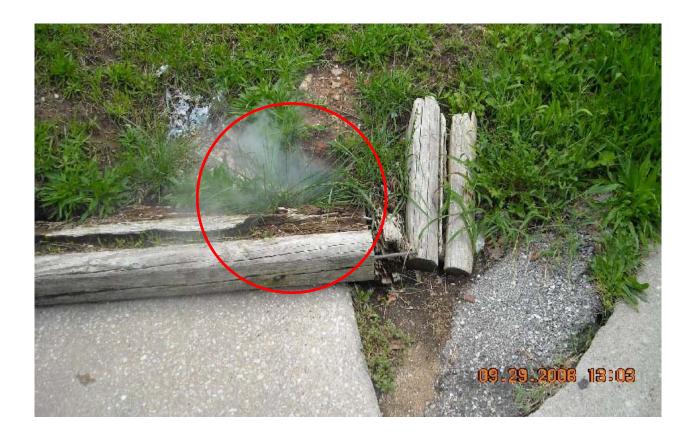
Photograph No: OB09-P01 Filename: S1039-005_OB09-P01.jpg

Defect No: OB09 Supervisor: E.R. Basin: Outfall

Source Type: 02 Service Line Sector: 02 Private

Location: 07 Yard - Front Severity: 03 Moderate Drainage Area: 4 ft²

Comments: Smoke is coming from a hole in the ground in the front of this address.

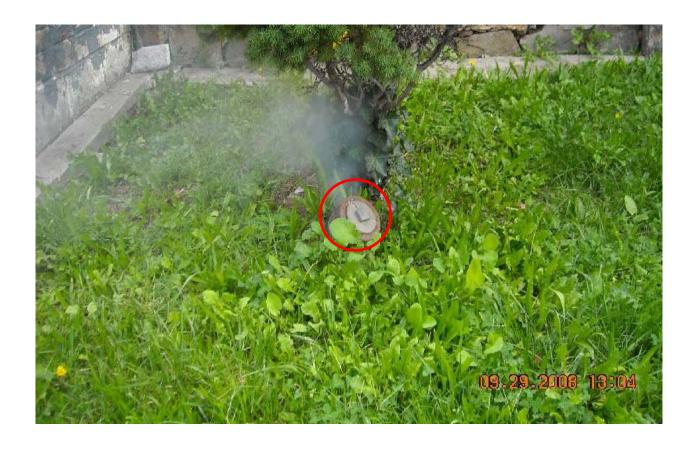
Photograph No: OB10-P01 Filename: S1039-005_OB10-P01.jpg

Defect No: OB10 Supervisor: E.R. Basin: Outfall

Source Type: 03 Cleanout Sector: 02 Private

Location: 07 Yard - Front Severity: 03 Moderate Drainage Area: 1 ft²

Comments: Smoke is coming from an above grade cleanout with a broken cap.

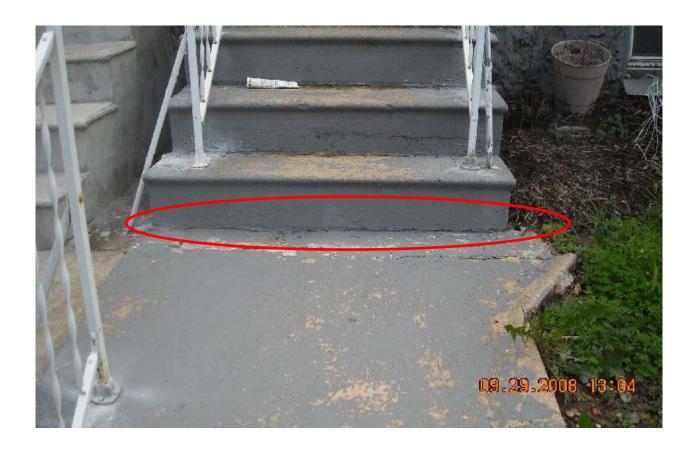
Photograph No: OB11-P01 Filename: S1039-005_OB11-P01.jpg

Defect No: OB11 Supervisor: E.R. Basin: Outfall

Source Type: 02 Service Line Sector: 02 Private

Location: 03 Paved Other Severity: 02 Trace Drainage Area: 12 ft²

Comments: Smoke is coming crack between sidewalk and first step.

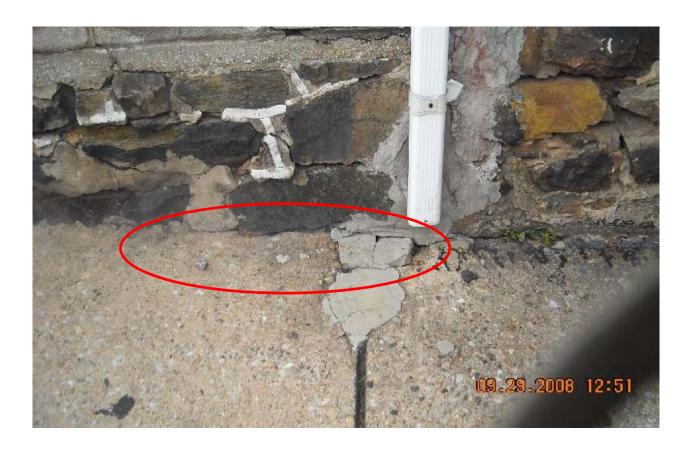
Photograph No: OB12-P01 Filename: S1039-005_OB12-P01.jpg

Defect No: OB12 Supervisor: E.R. Basin: Outfall

Source Type: 01 Main Sewer Sector: 02 Private

Location: 12 Alley Severity: 03 Moderate Drainage Area: 4 ft² Comments: Smoke is coming from the crack along the wall and alley on side of 3117 E. Preston St.
